# NHDOT SPR2 PROGRAM

## RESEARCH PROGRESS REPORT

<b>Project #</b> 26962M	<b>Report Period</b> Year: 2018 <input type="checkbox"/> Q1 (Jan-Mar) <input checked="" type="checkbox"/> Q2 (Apr-Jun) <input type="checkbox"/> Q3 (Jul-Sep) <input type="checkbox"/> Q4 (Oct-Dec)	
<b>Project Title:</b> Evaluation of Gusset-less Truss Connection to Aid Bridge Inspection and Condition Assessment		
<b>Project Investigator:</b> Erin S. Bell <b>Co-Project Investigator:</b> Ricardo A. Medina <b>Phone:</b> (603)862-3850 <b>E-mail:</b> erin.bell@unh.edu		
<b>Research Start Date:</b>  December 15, 2016	<b>Research End Date:</b>  December 31, 2018	<b>Project schedule status:</b>  <input type="checkbox"/> On schedule <input type="checkbox"/> Ahead of schedule <input checked="" type="checkbox"/> Behind schedule

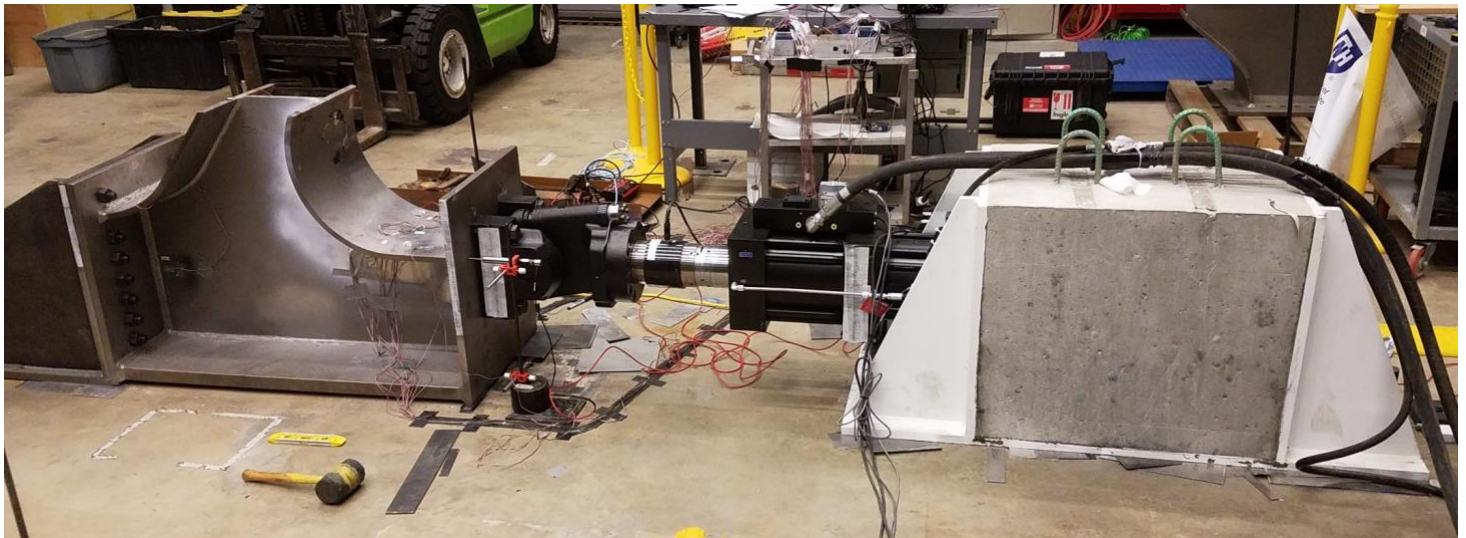
Figure 3: Testing apparatus with instrumented specimen

At the beginning of this quarter, the support components of the test setup were delivered. In addition, the two specimens were obtained from CANAM Bridges (same fabricators of the Memorial Bridge gusset-less connection). The specimens were sand blasted prior to shipping. Figure 2 shows a layout of the setup, and Figure 3 the testing apparatus with the instrumented specimen.

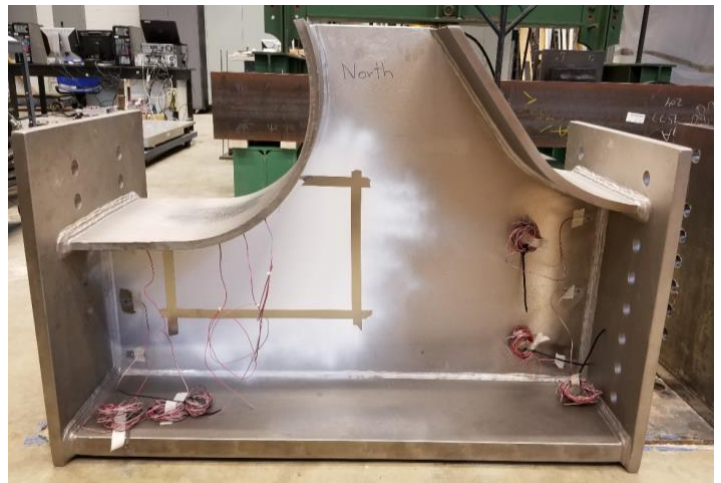
Figure 6: Instrumentation for initial test

In this test, both two- and three-dimensional DIC will be used. The two-dimensional DIC was used to capture strains and displacements in the web of the connection during an initial static-loading test. Figure 6 shows a picture of the instrumentation for the initial test. The goal of this initial test was to use two-dimensional DIC to identify the strain contours of the specimen given the applied load, which should reasonably match the strain contours provided by the analysis conducted by HNTB Corporation, as well as the strain contours from the finite element model (FEM) of the connection developed at UNH. Figure 7 presents an image of the Abaqus model developed and used at UNH. These measurements were compared to those obtained from the strain gauges in NUI1, NUI2 and NUI3 (Figure 5) to verify that the measurements were accurate and finalize the locations at which the strain rosettes were placed for the fatigue test.
